WESTERBEKE

SERVICE BULLETIN #10

SUBJECT: Sea Water Pump Clearance and Alignment

MODEL: Westerbeke 40 and WPDS 10-15

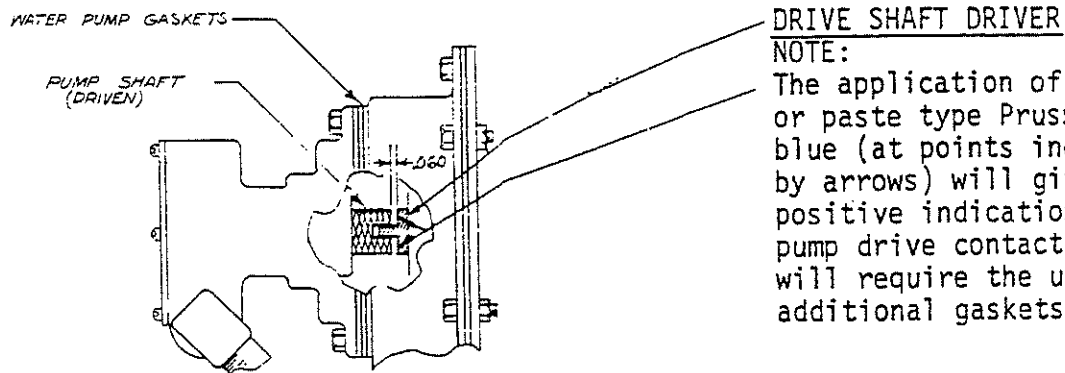
Adequate longitudinal clearance between the sea water pump shaft and the driving shaft is established by the use of multiple pump gaskets. The number of gaskets required can vary from 1 to 4. Enough gaskets must be used so that the shaft ends do not mate. See figure 1.

The application of liquid or paste type Prussian blue (at points indicated by arrows) will give positive indications of pump drive contact which will require the use of additional gaskets.

If the proper clearance is not maintained, the sea water pump shaft will force the fuel pump drive hub against its bushing. The bushing will seize to the drive hub and rotate in its housing. Bushing wear and loss of oil pressure will result.

When replacing the sea water pump be sure that the same number of gaskets is replaced and there is the required clearance.
