# SERVICE BULLETIN

**BULLETIN NUMBER:** 259

**SUBJECT:** Drive Belt Tension

3.0 BPMG-612

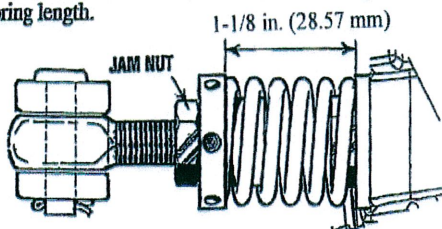
The engine's drive belt is located under the engine. To access the belt, for inspection and/or adjustment, remove the cover as shown. Inspect the belt for wear along the edges and for proper belt tension (belt should be tight).

The belt tension can be checked by measuring the spring length.

**DETAIL:** The generator drive belt tension specification as shown/illustrated in the Operator's Manual publication #048009 is in error. It does not coincide with our engineering design and the actual adjustment being set by our manufacturing department. The adjustment specification of 1-1/4 inches (31.79mm) should be 1-1/8 inches (28.57mm).
