# SERVICE BULLETIN

BULLETIN NUMBER: 106

MODEL: DS5, DS7, W-7

SUBJECT: Sea Water Pump Weep Hole

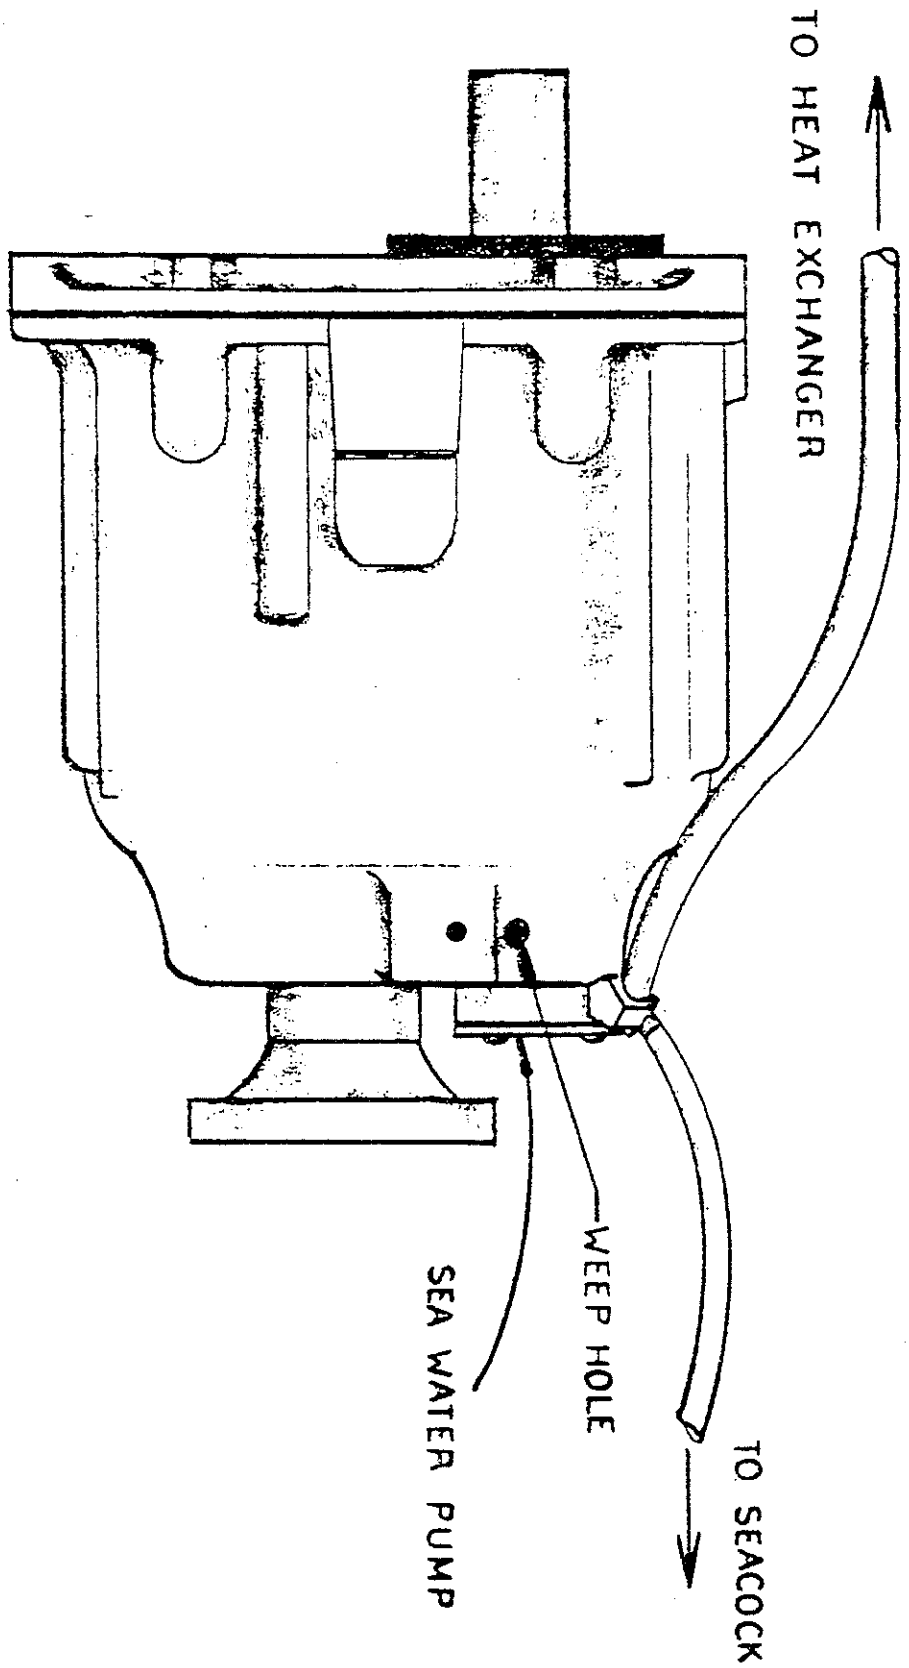
When performing daily engine checks, owners should pay particular attention to the weep holes just behind the sea water pump, which are visible on either side of the transmission. If there is any indication of sea water coming out of these weep holes, owners must remove the sea water pump and replace the seal (P.N. 16663) between the pump and the weep holes.

Failure to replace the seal when leakage is found at these weep holes will eventually lead to sea water entering the transmission.

Note: Leakage from these weep holes can also be caused by a blockage in the sea water flow through the engine or heat exchanger cooling circuit.

Ensure that these weep holes are not obstructed in any way by rust or scale build-up.
