# SERVICE BULLETIN

SERVICE BULLETIN #250

MODELS: BT GENERATORS

SUBJECT: TRANSFORMER INSTALLATION

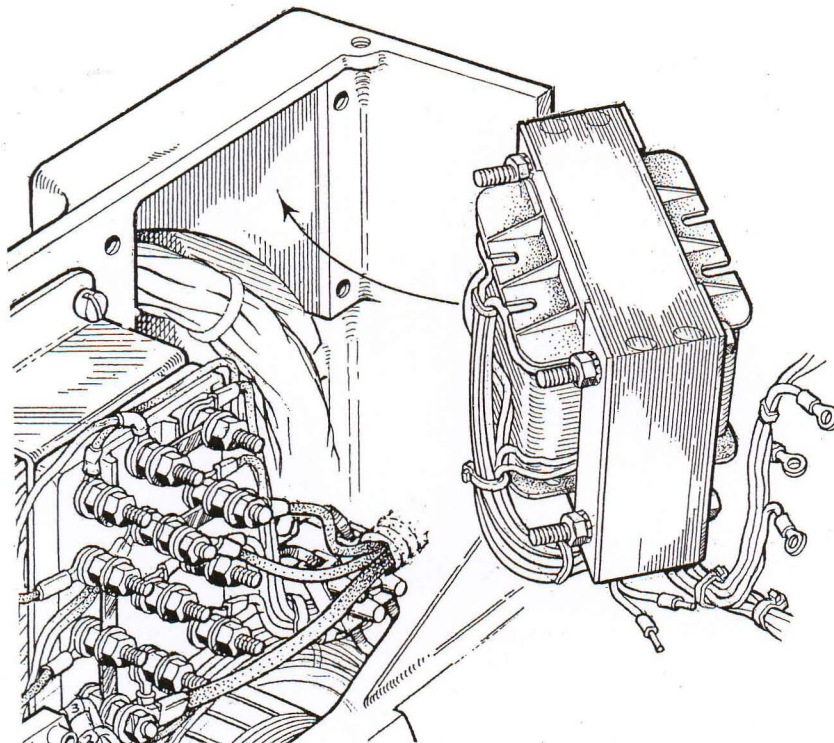
INSPECTION OF THE FAILED TRANSFORMER HAS SHOWN THAT THE WIRES ROUTING OUT OF THE TRANSFORMER TO THE AC TERMINAL BLOCK CONNECTIONS AND THE AC CONNECTIONS OF THE STATOR WINDINGS WERE ALLOWED TO COME IN CONTACT WITH THE METAL CAST HOUSING OF THE GENERATOR BEHIND THE TRANSFORMER.

THIS CAUSED THE INSULATION ON SOME OF THESE WIRES TO CHAFF AND ALLOWED THE WIRES TO GROUND TO THE METAL OF THE GENERATOR HOUSING CREATING AN ELECTRICAL SHORT WHEN THE GENERATOR WAS OPERATING.

WHEN INSTALLING A REPLACEMENT TRANSFORMER, CARE **MUST** BE TAKEN TO ENSURE THAT THE ROUTING OF THESE WIRE CONNECTORS FROM THE TRANSFORMER TO THE AC TERMINAL BLOCK AND AC STATOR CONNECTIONS **DO NOT** CONTACT THE METAL HOUSING OF THE GENERATOR.

PROVIDE PROTECTION FOR THESE WIRES WHEN NEEDED BY USING CHAFFE RESISTANT SHRINK WRAP.
