SERVICE BULLETIN

BULLETIN NUMBER: 276

SUBJECT: Generator Drive Belt Performance

AFFECTED: 3.5 SBCG and 3.0 BCG Gasoline Generators

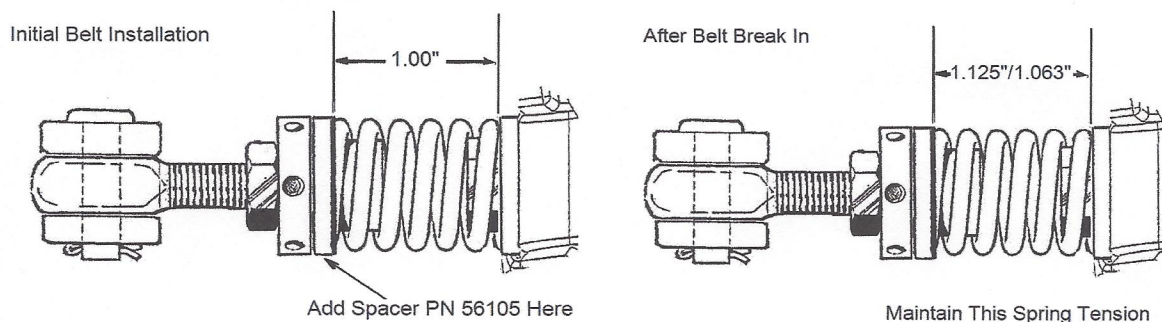
Manufacturing of new products includes, for optimum and rapid belt break in, adjusting the belt tension spring to 1.00" in our assembly process as illustrated below. After the first hour of run time, if necessary, it is readjusted to 1.00" prior to releasing the unit for shipment.

Important Note: Maximum performance of the drive belt and prevention of potential failure due to incorrect tension requires maintaining the belt tension spring to maximum 1.125" and minimum 1.063" at the recommended first 50 hour maintenance interval.

Generator drive belts sold for regular maintenance replacement part numbers change to 56107 for 60HZ and 56108 for 50HZ and they are a kit with instructions that includes the required spring spacer. Replacing the pulley is not required. Initial adjustment of the belt with the spacer installed is 1.00". After running the unit for 1 hour varying AC loads, the belt must be adjusted again to 1.00". After 50 hours run time, or during the next scheduled service, inspection and adjustment to 1.125" to 1.063" is required for proper belt tension.

Note: Used generator drive belts removed should not be re-used. Always replace with new using this new adjustment procedure.
