WESTERBEKE

SERVICE BULLETIN #84

ISSUED: September 4, 1975
SUBJECT: Heat Exchanger Rubber End Cap
MODEL: A11
DISTR: Distributors, Engine Shipments

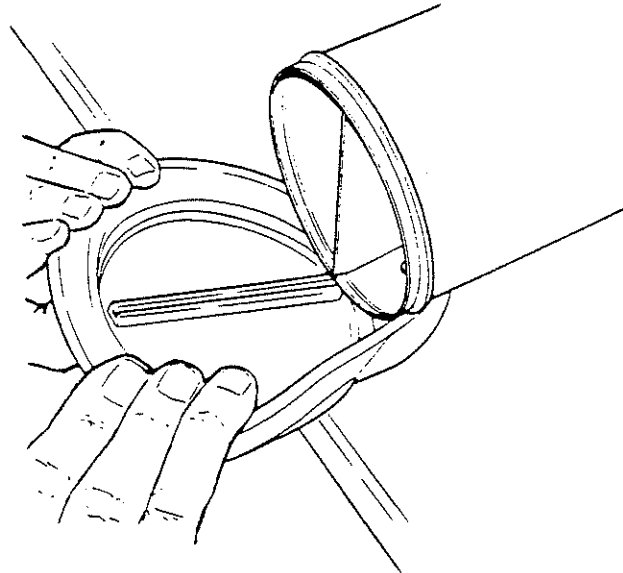
It is absolutely essential that the molded channel running across the inside of the cap be positioned over the baffle of the heat exchanger, according to the drawing below.

There have been occasions on which engine overheating has been caused by the improper positioning of this rubber end cap.

In any cases of engine overheating where such a rubber end cap is used, it should be checked for proper positioning along with other routine troubleshooting.
